**EPA REGION 6  
AIR INSPECTION REPORT**

FRS #: 110000504268 Inspection Dates: **October 10-12, 2012**  
AFS #: 48-201-00153  
Type of inspection: Clean Air Act, Partial Compliance Evaluation  
Company Name: **INTERCONTINENTAL TERMINALS COMPANY LLC**  
Facility Name: **INTERCONTINENTAL TERMINALS DEER PARK TERMINAL**  
Physical Location: 1943 Independence Parkway South (also known as Battleground Road)  
Deer Park, Texas 77536  
Mailing Address: P.O. Box 698  
Deer Park, Texas 77536-0698  
County/Parish: **Harris County**  
Reg. Programs: **SIP, Title V, MACT, NESHAP, and NSPS**  
SIC Code: 4226 and 4953

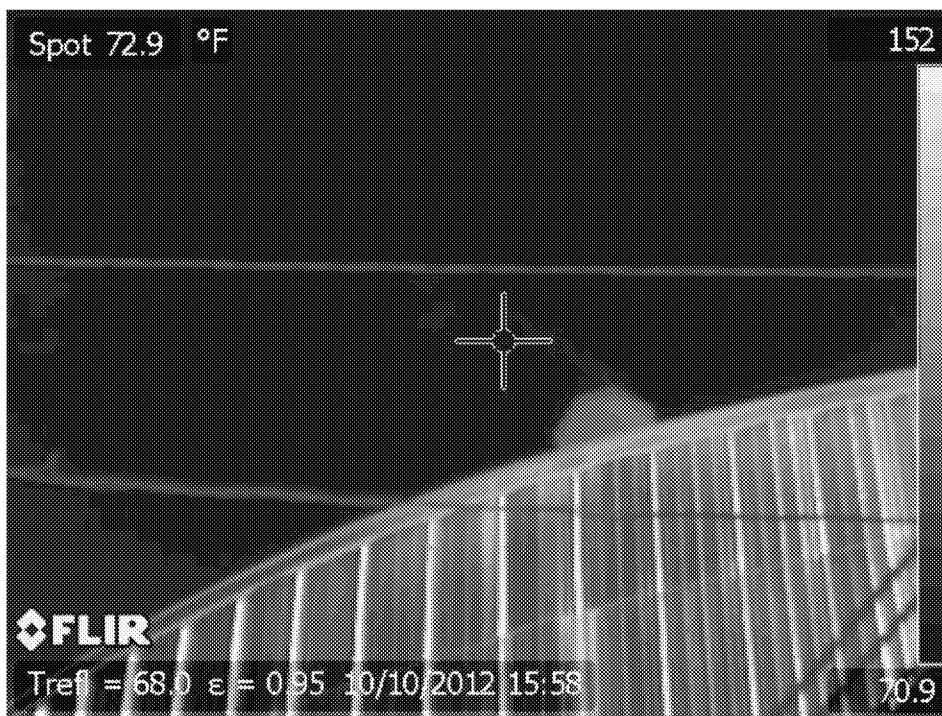
**Photo 1**

The only notable PID data that I recorded ~~associated with ITC Deer Park~~ were PID readings downwind from Tanks 80-7 ~~and~~ 80-9 on October 10, 2012 around 16:03. ~~I recorded with 15-second average Tiger PID VOC concentrations up to 0.53 ppm as isobutylene and 15-second Tiger Select PID VOC concentrations up to 0.27 ppm as benzene.~~ An IR camera photo taken by Cary and included as Attachment 7 shows emissions detected in auto mode coming from a vent on the roof of Tank 80-9.

**Tank 80-9, IR Image Showing Emission in Automatic Mode from Vent on Roof of Insulated Tank. Picture taken by Cary Secrest at 15:58 on October 10, 2012 (IR\_0429).**
